Honeycomb in Concrete

Structural Guide

Civil & Structural Engineering Knowledge Base

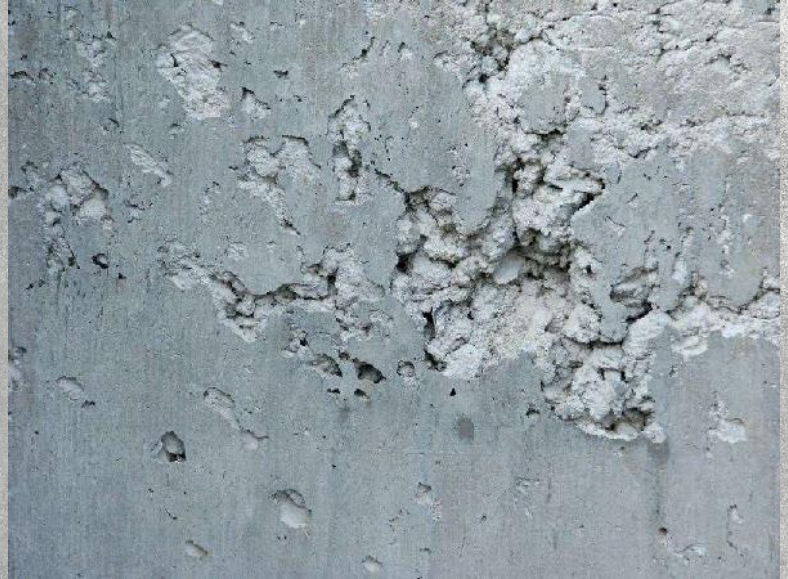
Honeycomb is the result of poor compaction of the concrete and the formation of cavities in the concrete. Generally, honeycombs in concrete are formed closed to the surface of the concrete.

However, due to the congestion in the reinforcement arrangements, there are possibilities of forming cavities internally. Further, there is minimal chance of noticing internal cavities.

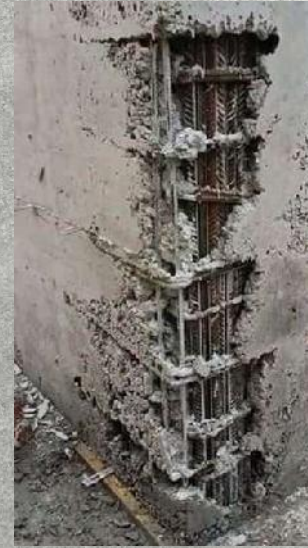
Cause of Honeycomb in Concrete

- Lack of workability of concrete
- Inadequate vibration and compaction
- Reinforcement congestion
- Segregation
- Inadequate cover to the reinforcement

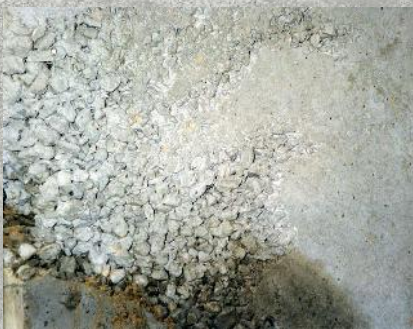
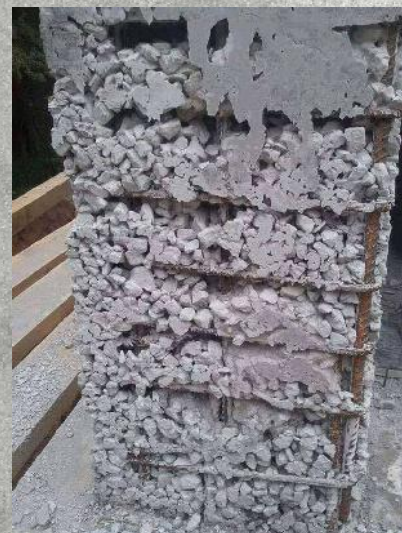
Effects of Honeycomb in Concrete

- Loss of strength / Reduce structural capacity
- Durability issues
 - Corrosion of reinforcement
 - Deterioration of concrete
- Water leaks in water retaining structures

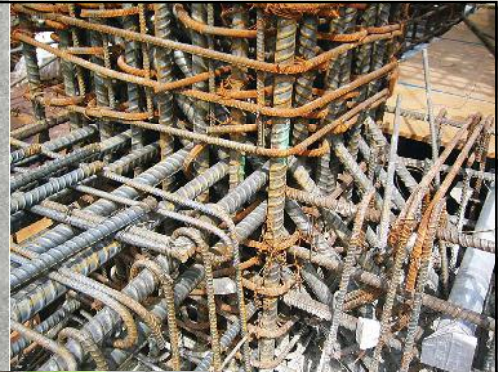
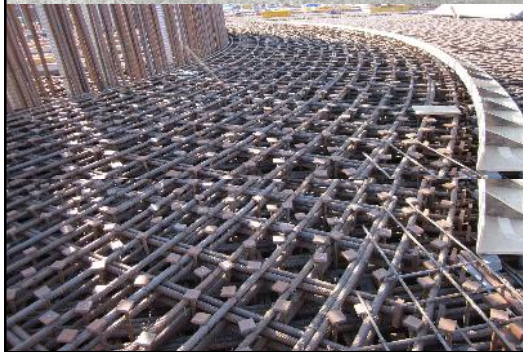
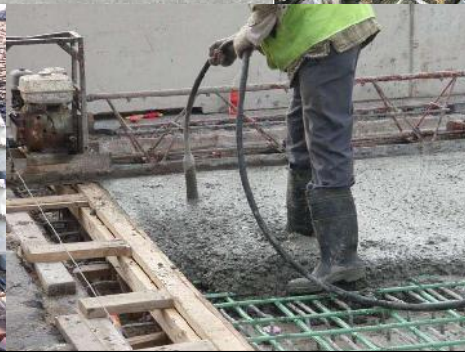
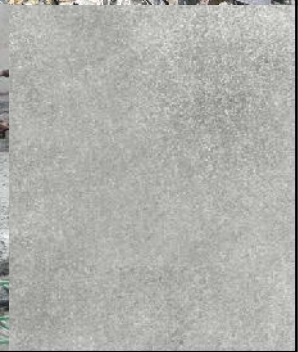
How to Prevent Honeycomb

Reinforcement Detailing

Improve Workability of Concrete

Maintain Adequate Gap Between Bars

Adequate vibration and Compaction of Concrete
